ADVANCE REPORT
on the
SEDIMENTATION SURVEY OF HAYES LAKE
HAYES, SOUTH DAKOTA

June 8-15, 1937

Sedimentation Studies
Division of Research
SCS-SS-20
July, 1938

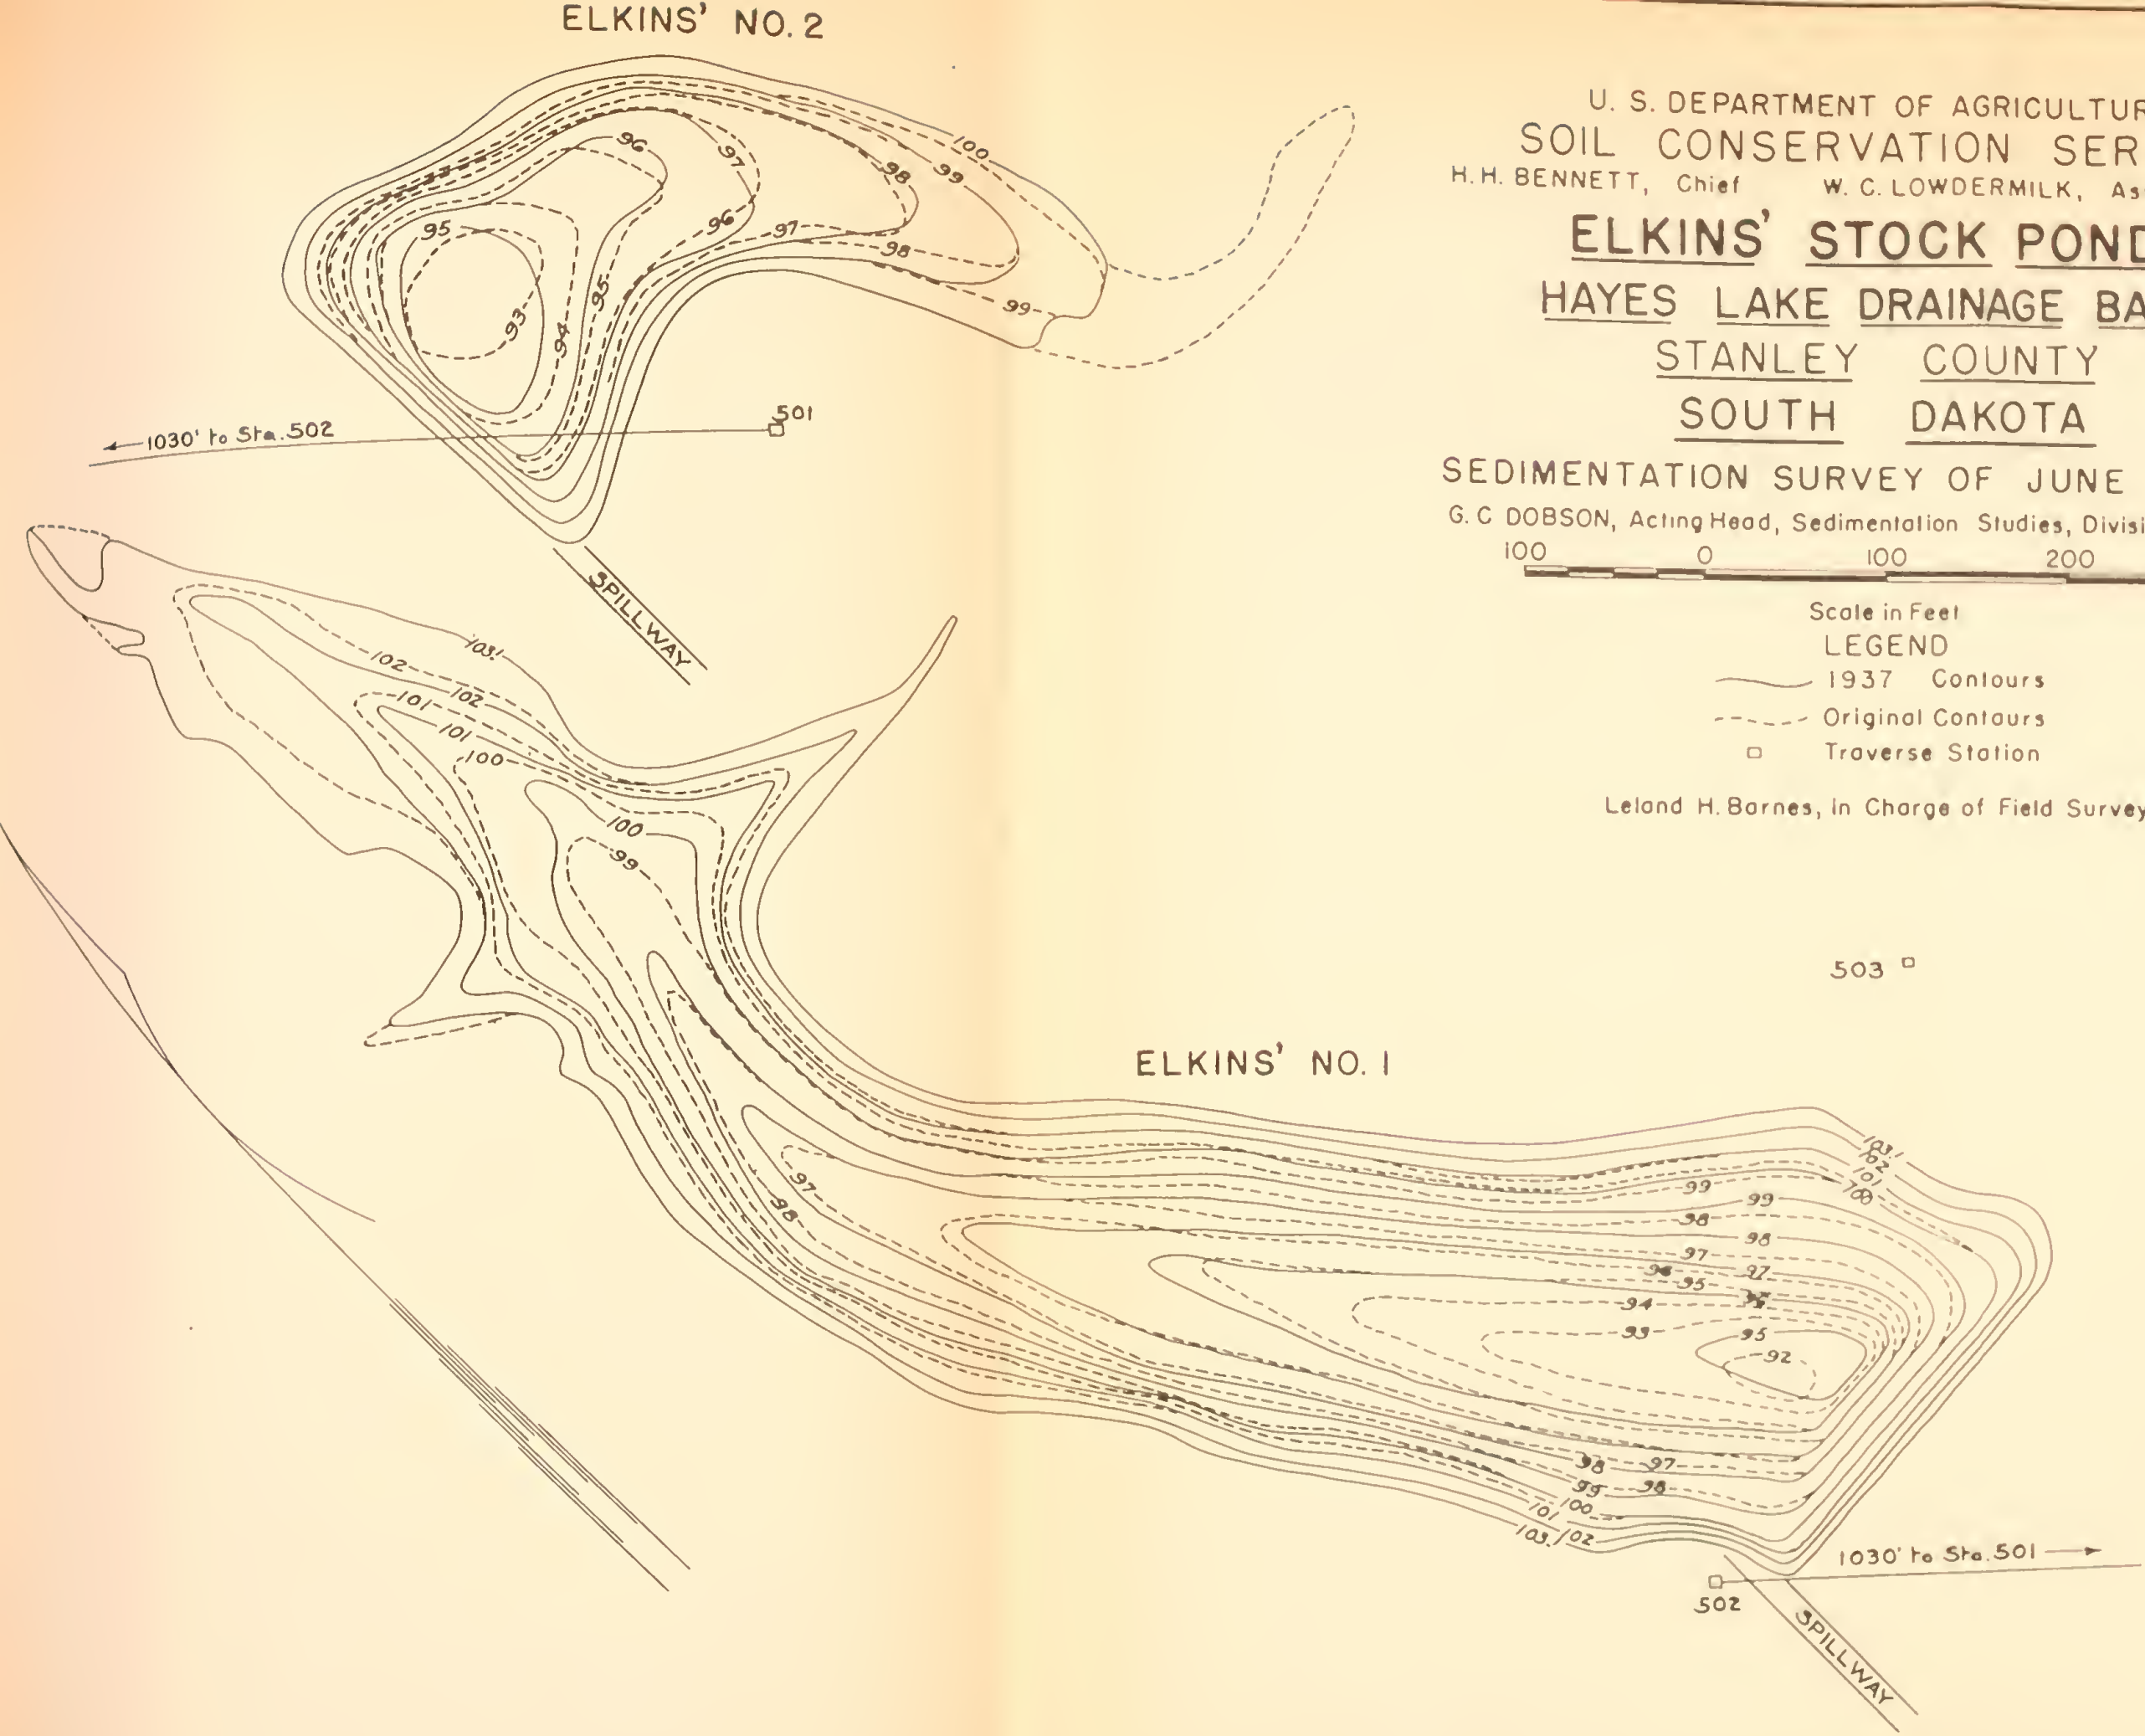
- 1937 Contours
- - - Original Contours
- Traverse Station

The pond occupies an elongated and comparatively straight and narrow basin varied only by two minor tributaries which enter near the head of backwater. (See fig. 6.) It is about 1,200 feet long and narrows rather uniformly upstream from a maximum width of 250 feet near the dam.
